AWS Field Report 2021-22

Field Team: Lee Welhouse and Dave Mikolajczyk

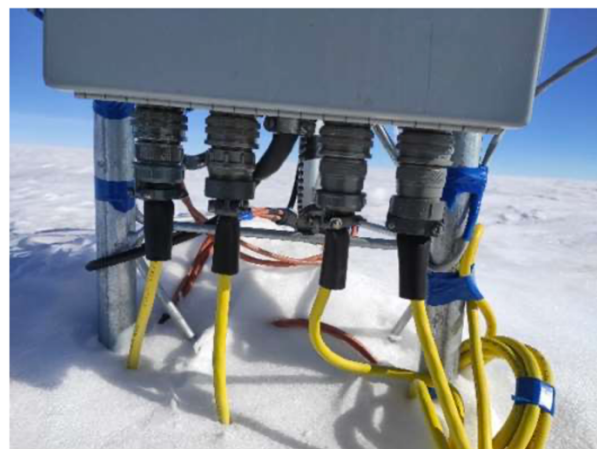
Power switch box. Cables 2 and 3 were loose.

I switched off the station, tight the connector and switch on the station.

The station seems working well after that. I don't know if it's due to the restart, the untight connector or both.

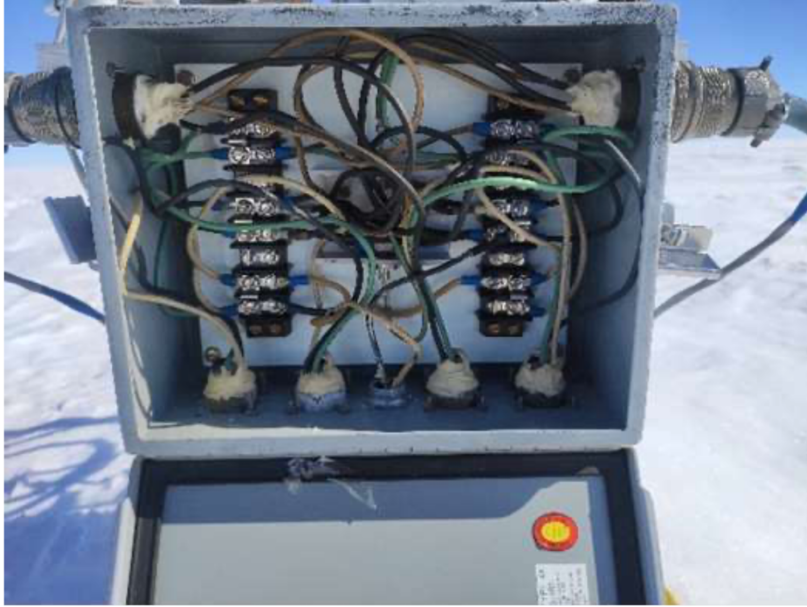
Inside power switch box

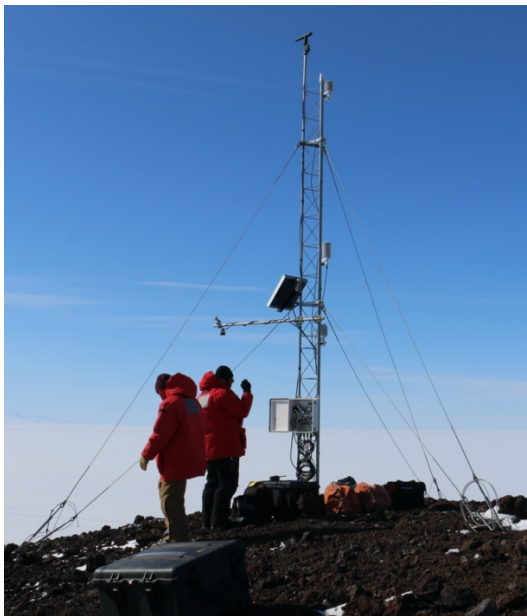
WTI had not been transmitting. Upon arrival, it was noted the wind monitor was missing its nose cone, propeller, and tail. We removed the wind monitor. The datalogger was still running, and the power system looked fine. We swapped data cards. The power system (3 100-AHr batteries) was good, but we replaced that with a new 3 100-AHr battery power system. We swapped the data card. The antenna cable was disconnected from the Iridium antenna (this is why WTI hadn't been transmitting) so we replaced the antenna cable. We plan to return to WTI to install a Taylor High Wind System.

WTI upon arrival

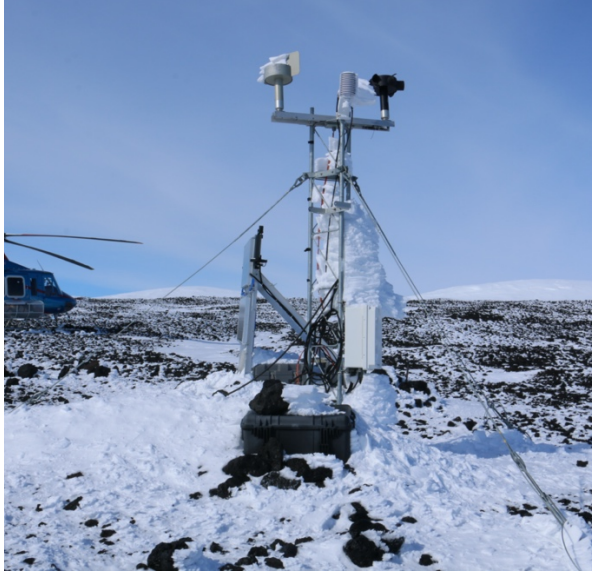
MNB had not been transmitting and was in rough shape. The datalogger wasn't running. The vibrations had backthreaded a lot of things, resulting in damage. The tape used to attach the cables to the tower broke, resulting in the cables pulling away from the tower. The boom cables had pulled themselves slightly out of the enclosure under the boom. The temperature sensor cable pulled, and the outer sheath was broken. We are relatively certain this resulted in damage to the cables that connect the wind direction. As such, the wind direction is not reporting correctly. Wind speed still seems to be valid. The I-beam mount is missing one bolt. HMP doesn't seem to be functioning. The antenna cable fully broke. The solar panel had fallen off its mount and was buried in snow a few feet from the tower. The existing power system Pelican case was damaged on the side facing the tower due to the twisting of the tower base scraping against it. The 2 100-AHr batteries were at 3 Volts with massive bulging batteries.

MNB upon arrival

We replaced the power system with 3 100-AHr batteries and used wire to tie down the boom as well as cabling. We wedged some rocks between the power system and tower base to prevent damage to the Pelican case. We reinstalled the solar panel, which has a 2-pin plug connecting to the power system. We replaced the antenna cable, retrieved the data card, confirmed the internal lithium was in good shape and confirmed transmission.

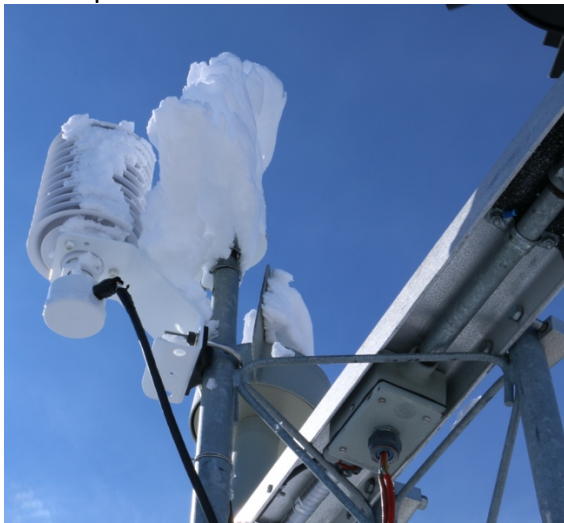
Damage to temperature sensor cable

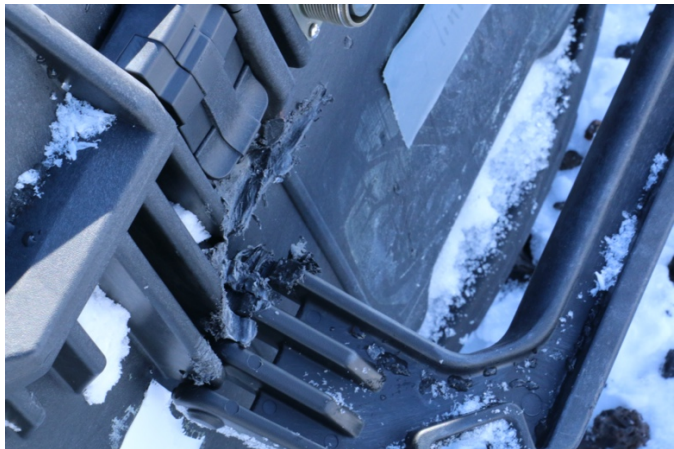
Damage to old power system case

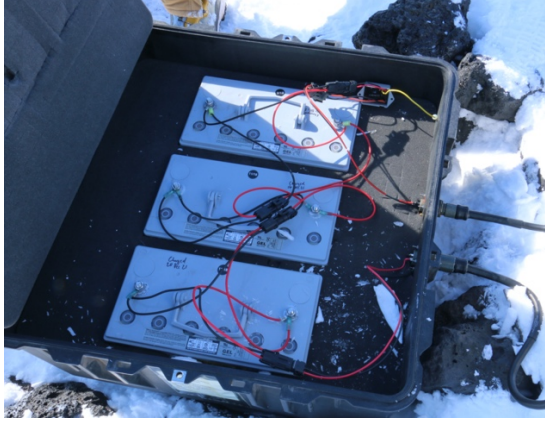
New power system

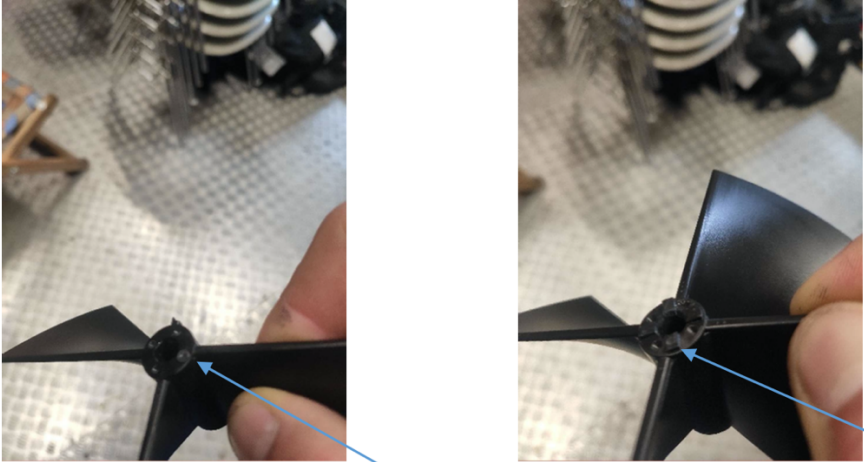
The anemometer was not well holded, during the work, we broke the propeller (13/01/2022). There was a spare in Prud'homme, we change it the 17/01/2022. We saw that the old propeller (the broken one) had not the little plastic part to maintain the propeller (see below).

D10 old propellor (left) and new (right)

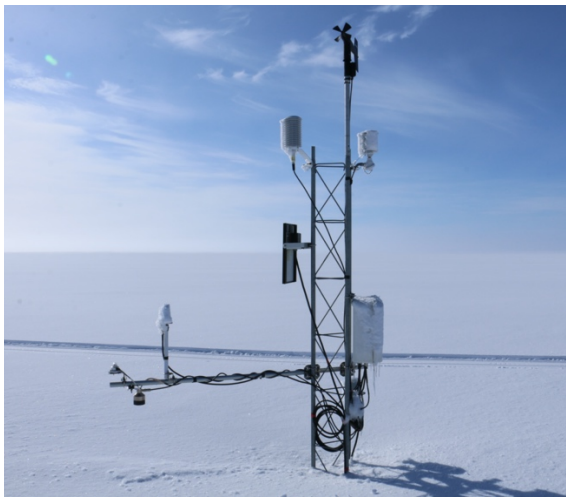
We swapped the enclosure due to the old CR1000 having a dysfunctional CF module. A Paroscientific pressure sensor (SN 52009) is now installed. We had to dig 7' 4" to get to the bottom of the power system. We raised that to the surface, added a 7-foot tower section, and raised instrumentation. One solar panel bolt is cross-threaded, so we will need to bring a new one for the next visit.

WDB before

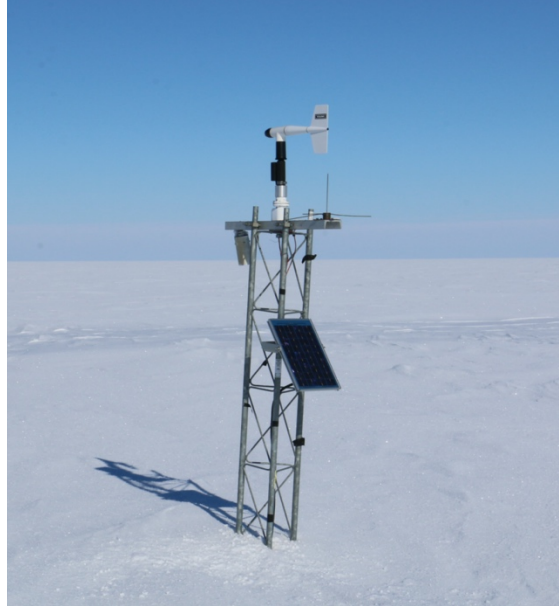
We knew the wind speed wasn't working, and we found the nose cone was damaged and the propeller was propelled about 30 feet. We replaced the nose cone and prop. We needed to dig down 7 feet 5 inches to recover the power system. Both of the old 100-Ahr batteries were starting to report low voltages, so we swapped them out with two new 100-Ahr batteries. We added a 10-foot tower section, reinstalled the instrumentation, and confirmed Argos transmissions with the Telonics. We found that the tower is tilted ~12.5 degrees off plumb.

EML upon arrival

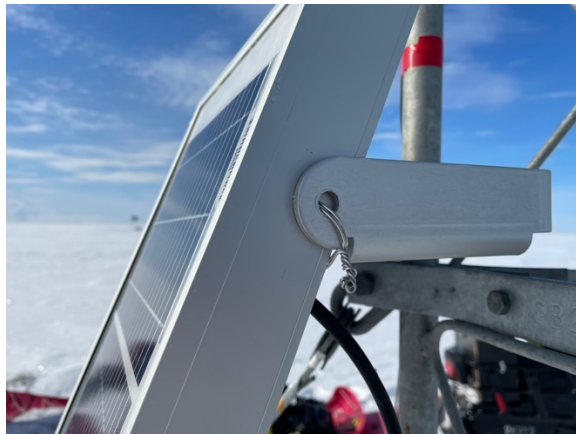
Wire used to attach solar panel to mount on SRH

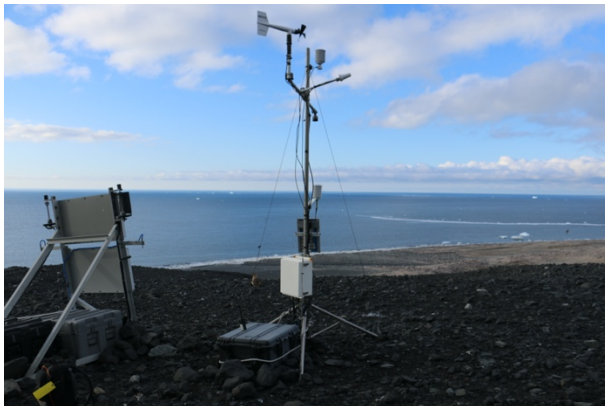
The antenna mount had shifted, and the antenna was pointing up the hill and putting pressure on the coax cable. The solar panel backing has stripped off so next year we should replace the solar panel. The tape used to hold the cables to the tripod had broken in two spots, we replaced it with lock wire. PASSCAL came along on the flight for a recce as they plan to put a station in close proximity next year.

CBD upon arrival
