Automatic Weather Station Field Report 2019-2020 Field Team: Lee Welhouse, Josh Thorsland, and Taylor Norton

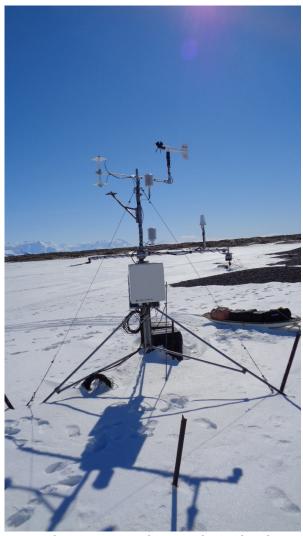
Cape Hallett Before

Work performed: Due to unknown reasons the A3LA-X modem buffers were failing to clear properly. This resulted in the modem not transmitting successfully. A new modem was installed and successfully transmitted.

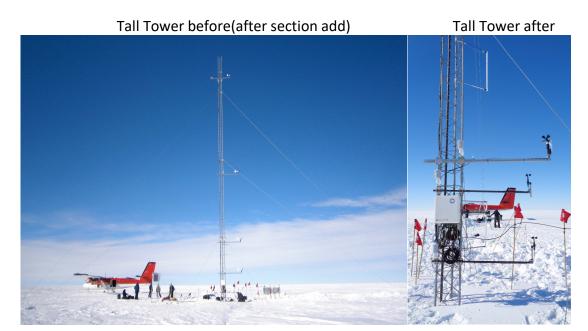
Work performed: Day 1 was primarily spent getting the tower prepped and raising the tower section and securing guy wires to return the tower to nominal height and some filming. Day 2 involved primarily filming and the raising of the lowest instrumentation to keep it from burial. Day 3 involved replacing the GPS sensors.

Heights before		After
Lowest Temperature	6"	41"
Lowest Wind	18"	32"
Acoustic Distance Gauge	10"	63"
2 nd level Temperature	52"	97"
2 nd Level Wind	41	90"

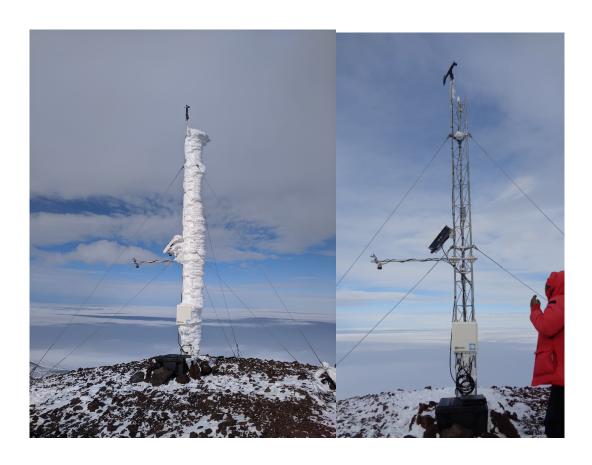
White Island before

Conditions: The site was very windy and had significant riming for the entire length of the tower

Work performed: Upon arrival the batteries were tested and found to be slightly bulged and failing to charge and reporting voltages below 5v. The entire battery system was replaced with new batteries, and the data card was swapped for a new data card.

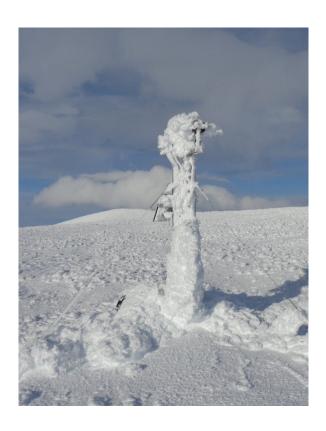
Minna Bluff Before

Work performed: The N connector at the enclosure was kinked and disconnected. We reconnected the connector and recrimped and taped the connector. The cable connection was secure.

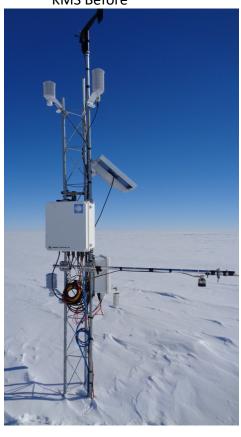
Work performed: The power system batteries were damaged and reporting extremely low voltage. They were replaced. We added a tower section, raised instrumentation, and removed the snow profile string as it could no longer be raised.

KMS	before	KMS after
Lower Temperature	e: 44"	121"
Upper Temperatur	e: 121"	211"
Wind:	153"	241"
Enclosure:	61"	61"
Net Radiometer:	50"	134"
Acoustic Depth Ga	uge: 47"	131"

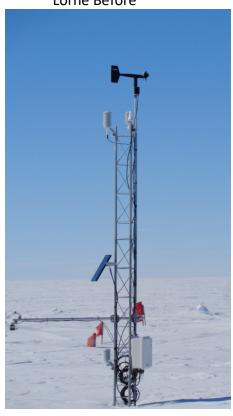
Lorne Before

Work performed: The enclosure and lowest instrumentation has been raised. The power system was approximately 12 inches below the snow surface so raising it wasn't

Lorne height	before	after
Lower temperature	22"	92"
Enclosure	21"	68"
Acoustic Depth Gauge	41"	91"
Pyranometer	50"	100"
Upper Temperature	184"	184"
Humidity	184"	184"
Wind	214"	214"

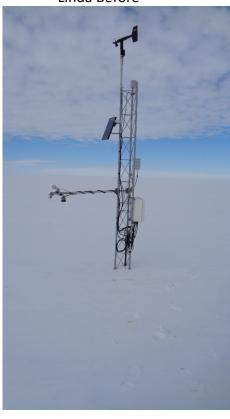
Linda Before

Work performed: The lowest instrumentation was raised; the tower was tall enough though approximately 4 degrees off plumb. The power system was close to the surface and doesn't need to be raised.

Linda heights	Before	After
Enclosure	36"	71"
Acoustic Depth Gauge	51"	85"
Pyranometer	62"	96"
Upper Temperature	132"	132"
Humidity	72"	72"
Wind monitor	162"	162"

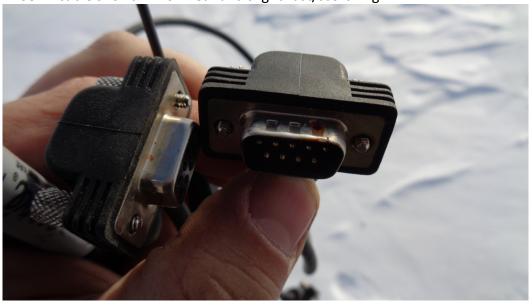
to the laptop. The CR1000 was found to communicate successfully through both the CS I/O port, as well as the RS-232 port. Once rebooted the cable failed to connect. Replacing the internal RS-232 cable successfully reestablished communications between the logger and the argos transceiver.

Phoenix cable shows minor wear and slight rust/scorching

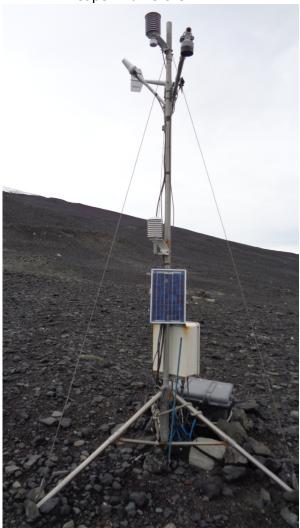
Cape Bird Before

Work performed: The site was inspected and was found to be in good shape, batteries remained at high voltage after solar power was covered. The antenna mount was off

plumb so it was returned to plumb. A cable ran through the U bolt and this was corrected. Corrosion on bolts and plugs continues, but doesn't seem to negatively impact the station. The wind generators at the power system are completely disabled.

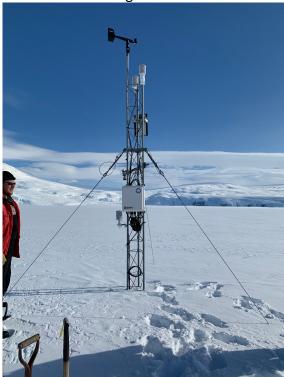
Windless Bight After

Work performed: The system was checked and tower was found to be nominal height. The guy wires were removed to prevent differential loading from tilting the tower. The power system was raised. The data logger indicated the card peripheral device wasn't detected. Upon removal oxidization was found on the connector on the CR1000 side. This indicates the CR1000 is damaged and should be replaced

Windless Bight Heights	Before	After
Lower Temperature	46"	75"
Enclosure	53"	89"
Acoustic Depth Gauge	81"	81"
Pyranometer	89"	89"
Humidity	146"	146"
Upper Temperature	146"	146"
Wind	177"	177"

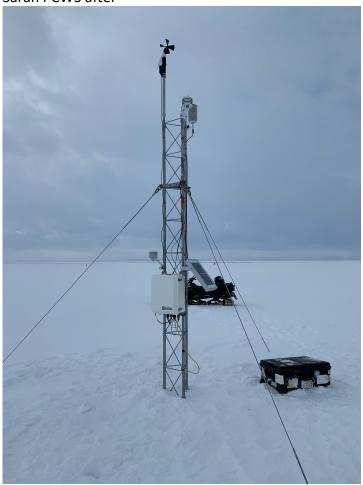
Sarah PCWS after

Work performed: Over multiple trips the old system was removed and the new one replaced with instrumentation and enclosure.

Enclosure 38" Lower Temperature 60" Upper temperature 131" Humidity 131" Wind 162"
