AMOMFW 2013 Madison, Wisconsin

Initial Analysis of Weather Conditions Around Mount Elizabeth on January 23, 2013

Karen Pon ^{1,2} and David Bromwich ^{1,2} ¹ Polar Meteorology Group, Byrd Polar Research Center ² Atmospheric Science Program, Department of Geography, The Ohio State University

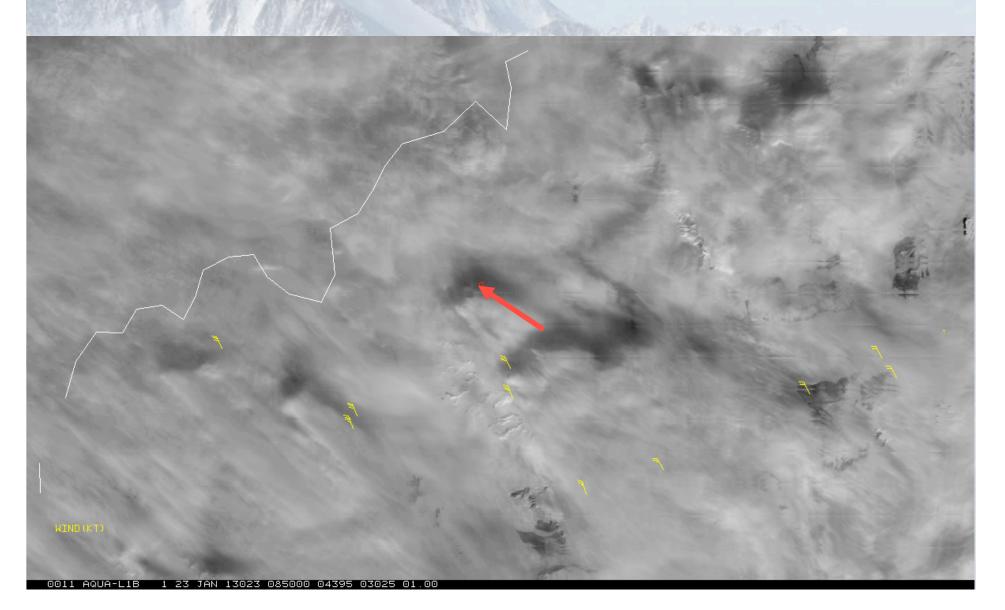
MODIS-AQUA Ch1 23/0850UTC

- Model and observational data do not suggest winds stronger than 35 knots around the time of the accident.
- Satellite imagery shows increased low and middle level cloud and possible mountain wave activity at later times, which may account for the conditions reported by the Search and Rescue teams.
