AWS Field Report 2021-22

Field Team: Lee Welhouse and Dave Mikolajczyk

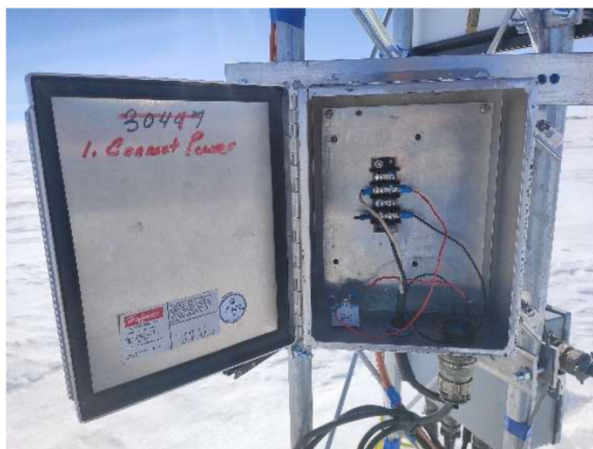
DC2 junction box

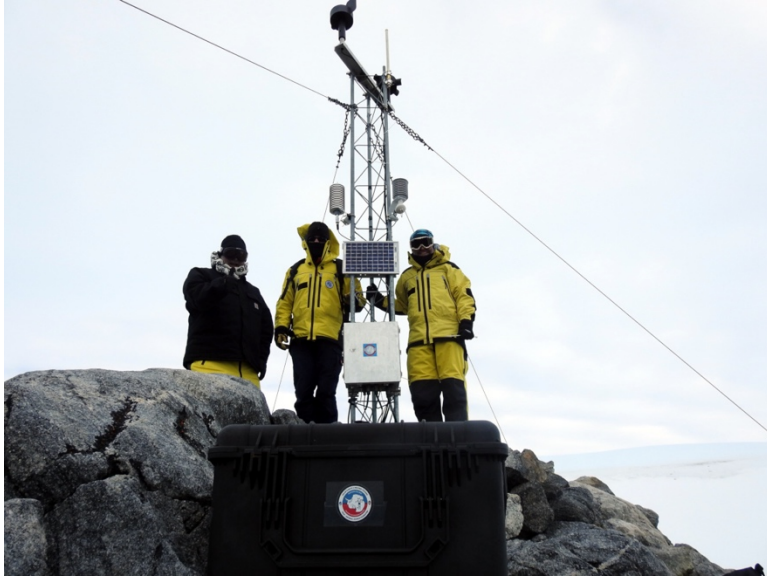
CDN after installation completed
