AWS Field Report 2021-22

Field Team: Lee Welhouse and Dave Mikolajczyk

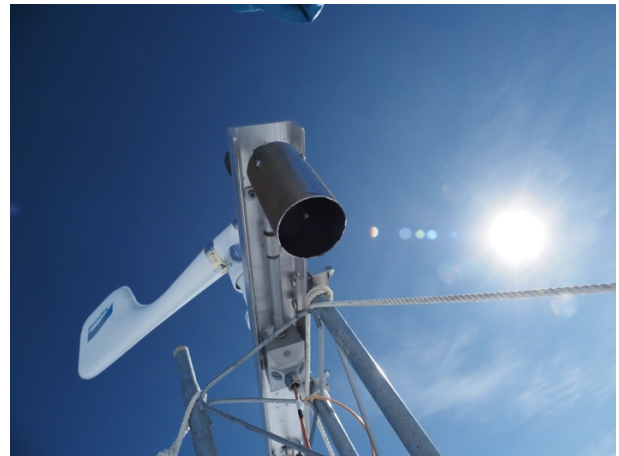
MIZ temperature sensor

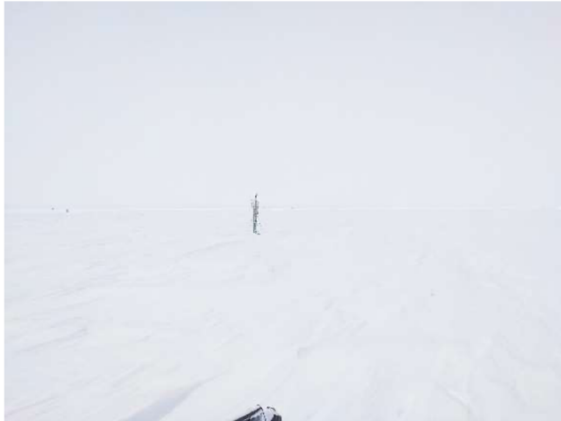
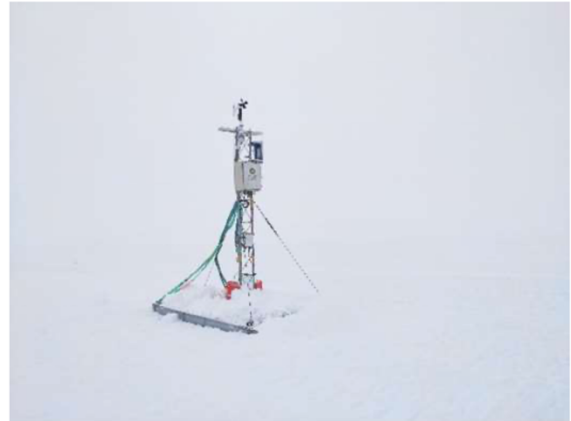
Snow removal and new position.

D85 before (left) and after (right)

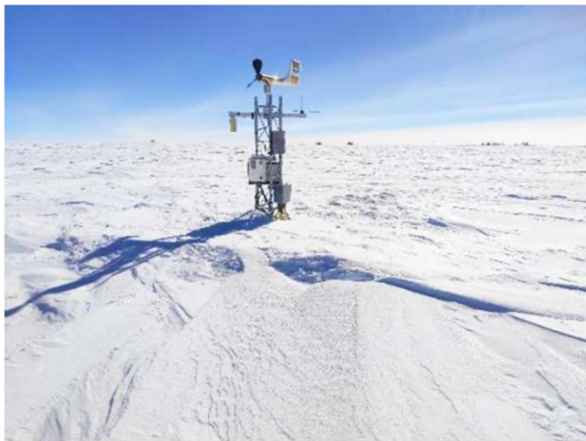
The station seems working well after that. I don't know if it's due to the restart, the untight connector or both.

DC2 upon arrival

I think, it could be a good thing to remove the snow of this station next year.

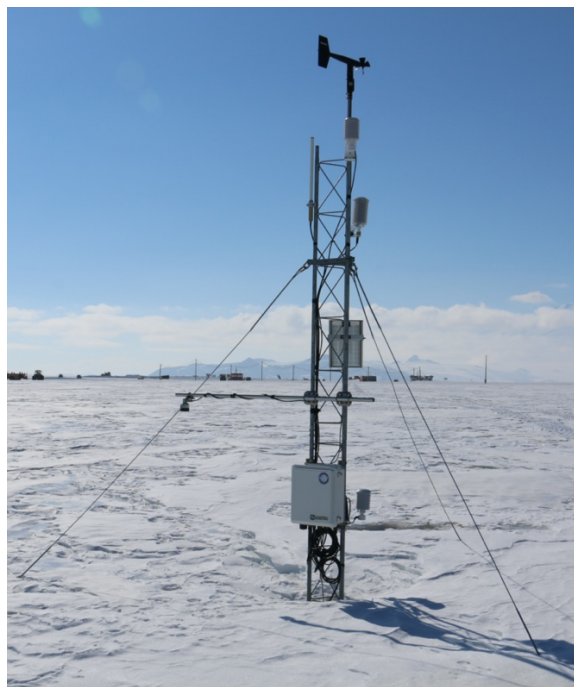
PHX before

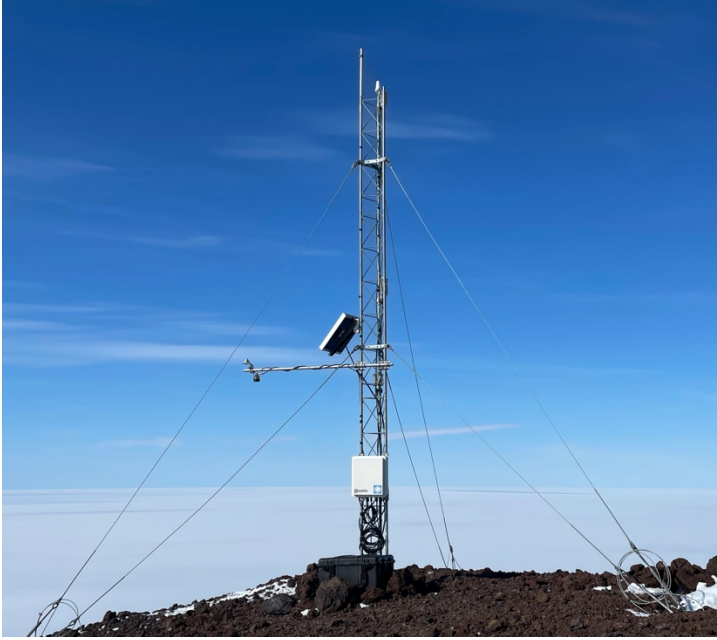
WTI after

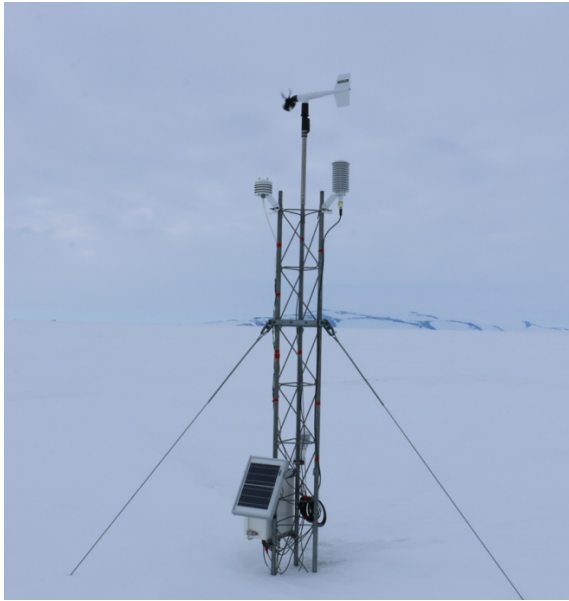
We raised the WFD power system to the surface. We removed SRH's power system because the Pelican case hinge was damaged. The top of the Pelican case was replaced in the lab.

SRH before

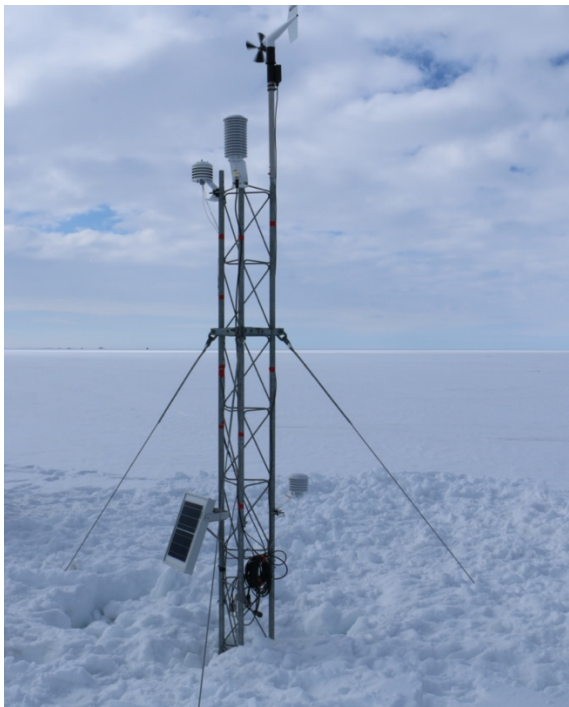
SRH after

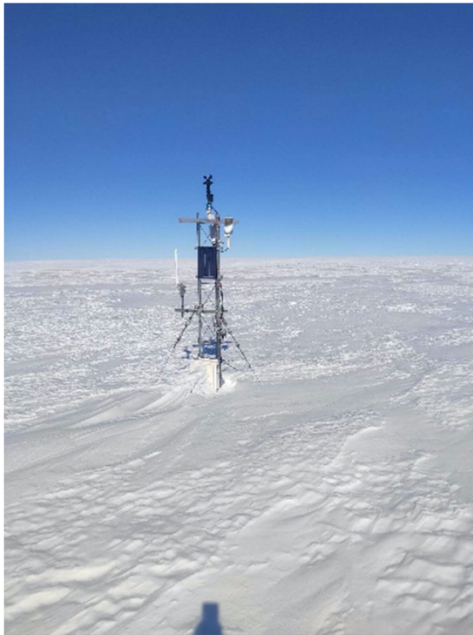
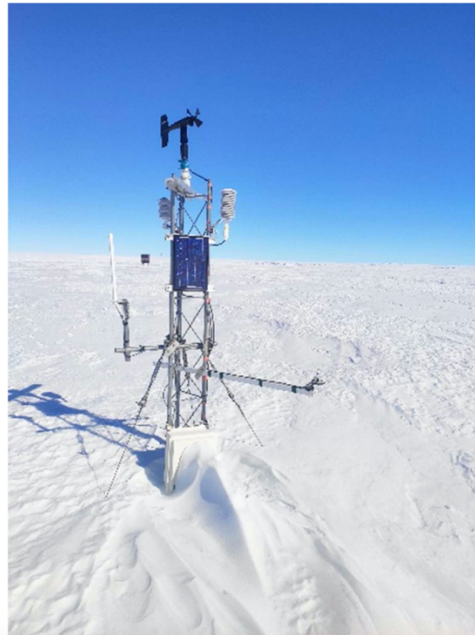
We change the HMP155 as requested. We also change the SR50 which was broken (there was a spare in Prud'homme) and we changed the cover of the low temperature sensor.

The anemometer was not well holded, during the work, we broke the propeller (13/01/2022). There was a spare in Prud'homme, we change it the 17/01/2022. We saw that the old propeller (the broken one) had not the little plastic part to maintain the propeller (see below).

D10 upon arrival

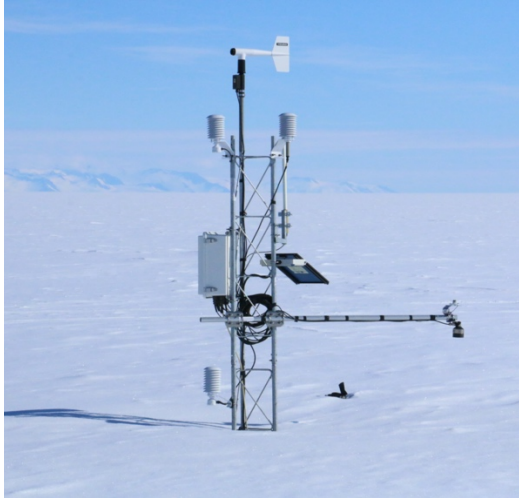
ELN upon arrival

We got out to Elaine and the data logger was functioning and we were able to recover the data card. The temperature sensor was reading "NAN" and we couldn't determine why. The lower temperature sensor was reading good values, so with some changes to the code we changed that to be the upper temperature sensor. We changed the wind monitor. The nose cone was found on the ground at the station, and both that nose cone and the vane itself had cracks/damage. We tried a different antenna with no success transmitting and moved on to trying a separate modem. That did the trick and we got it transmitting again. We added a 7-foot section. The power system was swapped out, and the old batteries were recovered (this likely wasn't needed but we felt it was better to do this now. There seemed to be an oddity with the power cable (one we purchased from PEI genesis in the past) that resulted in the A and B sockets being on the wrong side of the plug. This resulted in the power being swapped (we discovered this prior to plugging in the data logger and corrected the wiring in the enclosure). The UNAVCO GPS was setup throughout the visit.

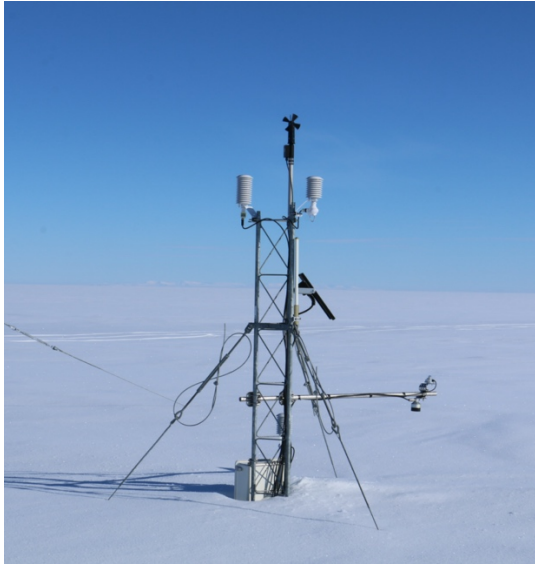
MLN before

We were successful in getting Marilyn back online. The lower temperature sensor wasn't working, and our efforts to repair it didn't work so we removed it. Perhaps we should consider having some spare half wire bridge replacements on hand to swap out in the future since we are seeing some of them fail (it is our best guess that these are the parts failing since the rest of the connections seemed good and we've seen them fail at other sites). The power system was in great shape upon arrival. We were able to recover the data card. The new wind bird still read bad values, so we swapped data logger cores and that fixed the issue. This seems to indicate the wind bird wasn't the issue, but the data logger half wire bridge measurement for the wind bird channel was. We are going to test that in the lab. Plus side, the only other measurement that would be similarly off would be the PRTs and the upper temperature measured the same on both data logger cores, so that shouldn't be impacted. We added a 7-foot tower section. The UNAVCO GPS was setup throughout the visit.

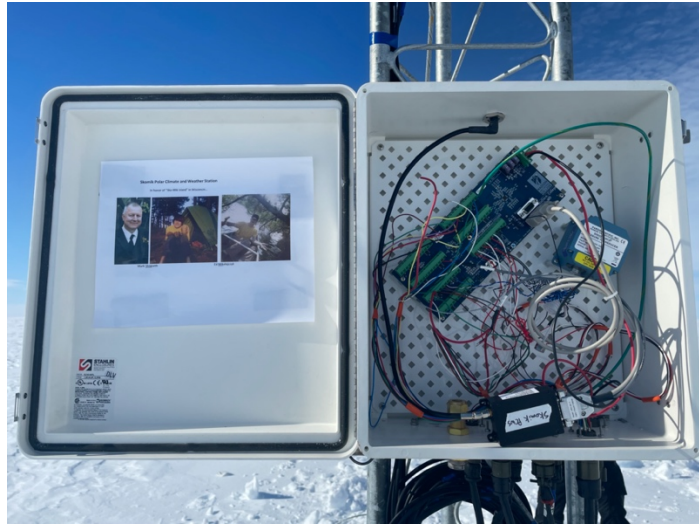
SKM enclosure

When that was completed, we uploaded the program to SKM, firmware version 2.1.3. However, after one successful transmission, the cable inside the enclosure connecting the Iridium antenna to the Iridium modem broke at the modem connection. We also noticed that the wind data and one of the upper thermistors seemed wrong. In troubleshooting the thermistor, one of them was damaged. We tried fixing the transmission issue but couldn't. We would try to come back to upload a new program and swap out the Iridium antenna and modem cable.
